Name Of Dam: SPRING VALLEY LAKE  
Location: CITY OF ROANOKE, VIRGINIA  
Inventory Number: VA 77002

## PHASE I INSPECTION REPORT NATIONAL DAM SAFETY PROGRAM

NOVEMBER 1980

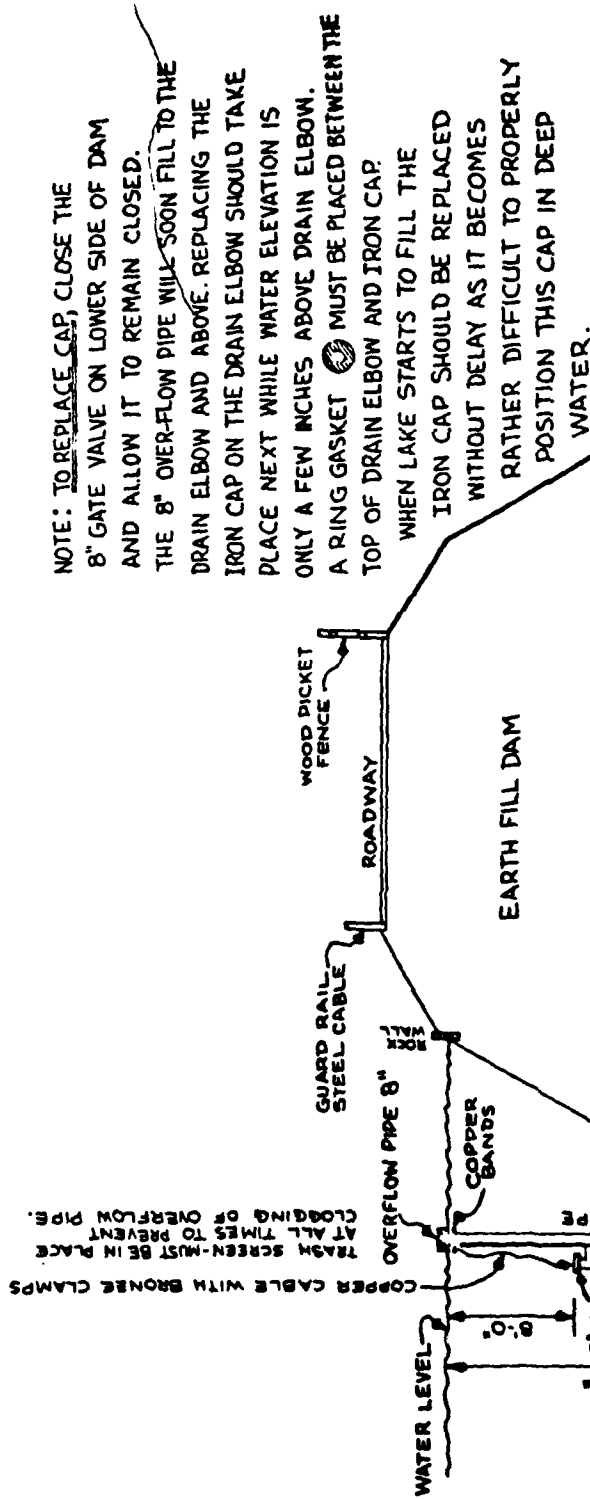
APPENDIX IV  
OPERATION OF OUTLET

TEACH SCREEN-MUST BE IN PLACE AT ALL TIMES TO PREVENT CLOGGING OF OVERFLOW PIPE.

NOTE: TO REPLACE CAP, CLOSE THE 8" GATE VALVE ON LOWER SIDE OF DAM AND ALLOW IT TO REMAIN CLOSED. THE 8" OVERFLOW PIPE WILL SOON FILL TO THE DRAIN ELBOW AND ABOVE. REPLACING THE IRON CAP ON THE DRAIN ELBOW SHOULD TAKE PLACE NEXT WHILE WATER ELEVATION IS ONLY A FEW INCHES ABOVE DRAIN ELBOW. A RING GASKET
